APOLLO PROGRAM

# FINAL FLIGHT EVALUATION REPORT APOLLO 10 MISSION

AUGUST 1969

FLIGHT EVALUATION REPORT - APOLLO 10 MISSION

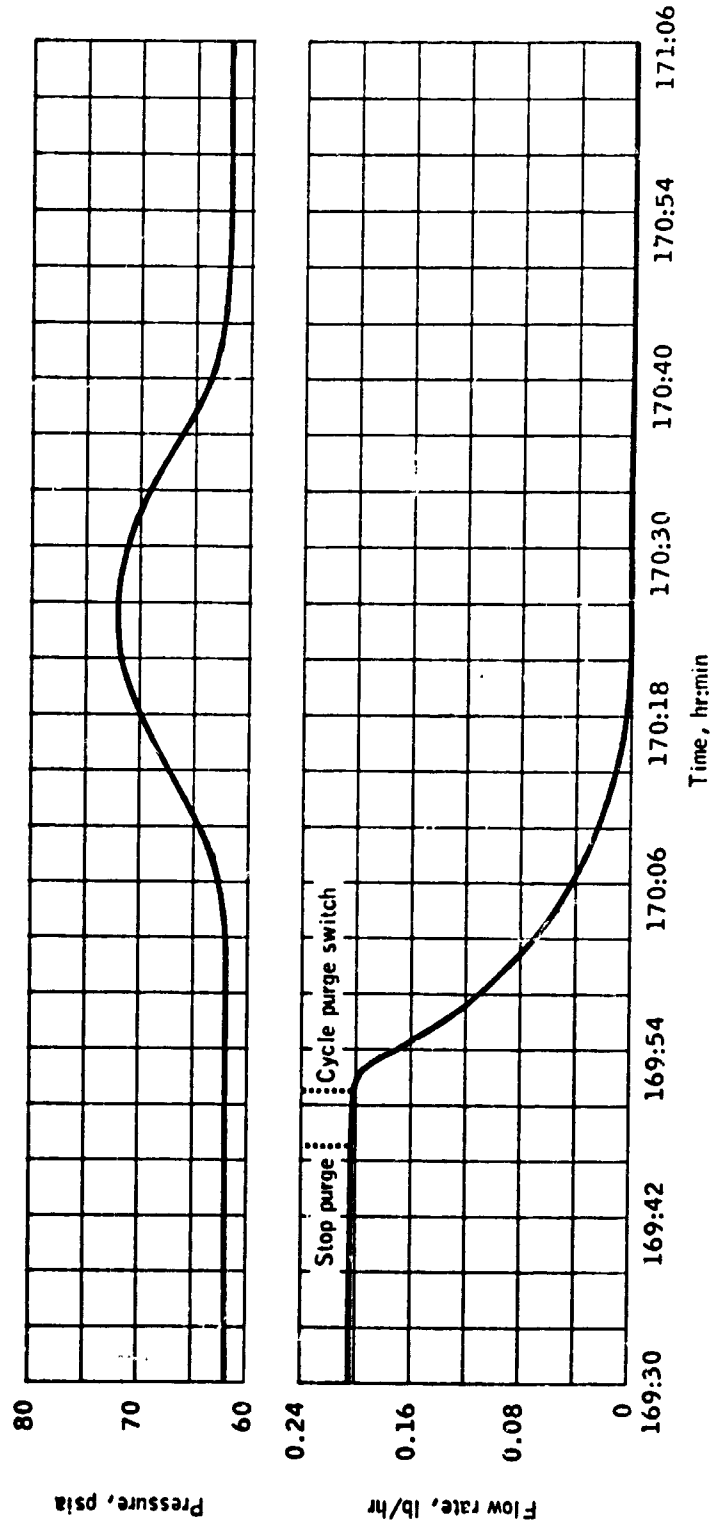
FIG. 2.2.14-1 FLOW RATE AND PRESSURE AFTER PURGE

<p>NO. 2.2.14</p> <p>SYSTEM: SM</p> <p>SUBSYSTEM:</p>	<p>TITLE: OVERPRESSURE OF REACTANTS IN FUEL CELL 1 WHEN PURGE VALVE CLOSED</p> <p>MISSION: APOLLO 10</p> <p>EVENT TIME: 169:56</p> <p>PROBLEM: AT 166 HOURS 49 MINUTES, THE SKIN TEMPERATURE OF FUEL CELL 1 WAS 420°F, AND A CONTINUOUS HYDROGEN PURGE WAS INITIATED TO REDUCE THE CONCENTRATION OF WATER IN THE ELECTROLYTE. THREE HOURS LATER, THE FUEL CELL WAS SUFFICIENTLY DRY AND HOT, THE PURGE WAS TERMINATED, AND THE HEATER FOR THE HYDROGEN VENT LINE WAS TURNED OFF. HOWEVER, HYDROGEN FLOW TO THE FUEL CELL DECAYED VERY SLOWLY (FIG.2.2.14-1), NORMALLY, FLOW DECAYS TO ZERO IN LESS THAN 1 MINUTE. THE PURGE VALVE WAS REOPENED, AND THE FLOW RATE INCREASED TO THE UPPER LIMIT, INDICATING THAT THE PURGE VALVE WAS FUNCTIONING. THE VALVE WAS CLOSED AGAIN BUT THE FLOW DECREASE WAS STILL VERY SLOW. AS THE FLOW RATE WAS APPROACHING ZERO AFTER ABOUT 30 MINUTES, THE REGULATED HYDROGEN PRESSURE FOR THE FUEL CELL BEGAN TO INCREASE REACHING A MAXIMUM OF 72 PSIA BEFORE SLOWLY DECAYING TO THE NORMAL 62 PSIA.</p> <p>ACTION: AS SHOWN IN FIGURE 2.2.14-2, THE REGULATOR OPERATION DEPENDS ON A REGULATED NITROGEN REFERENCE PRESSURE. THE NITROGEN PRESSURE DID NOT CHANGE DURING THE HYDROGEN PRESSURE EXCURSION, NOR DID THE REGULATED OXYGEN PRESSURE, ELIMINATING THE POSSIBILITY OF A REFERENCE PRESSURE CHANGE.</p> <p>GROUND TESTS DEMONSTRATE THAT THE EXTENDED HYDROGEN PURGE IN FLIGHT CREATED LOW TEMPERATURES ON THE REGULATOR; THE CONSEQUENT REGULATOR LEAKAGE EXPLAINS THE CONTINUED FLOW. WITH THE HEATER OFF, THE VENT LINE BECAME BLOCKED, LEADING TO THE INCREASE IN REGULATED HYDROGEN PRESSURE.</p> <p>FOR FUTURE MISSIONS, EXTENDED HYDROGEN PURGING FROM CRYOGENIC TANKS WILL NOT BE PERFORMED. FOR A GREATER MARGIN OF OPERATIONAL ASSURANCE, THE VENT LINE HEATER WILL BE LEFT ON FOR 10 MINUTES AFTER TERMINATION OF A HYDROGEN PURGE. THIS CHANGE HAS BEEN INCORPORATED INTO THE APOLLO OPERATIONS HANDBOOK.</p> <p>ORGANIZATION: 5-2490</p> <p>REFERENCES: APOLLO 10 MISSION FAILURE AND ANOMALY LISTING</p> <p>RESOLUTION: CLOSED</p> <p>DATE:</p> <p>REV:</p>

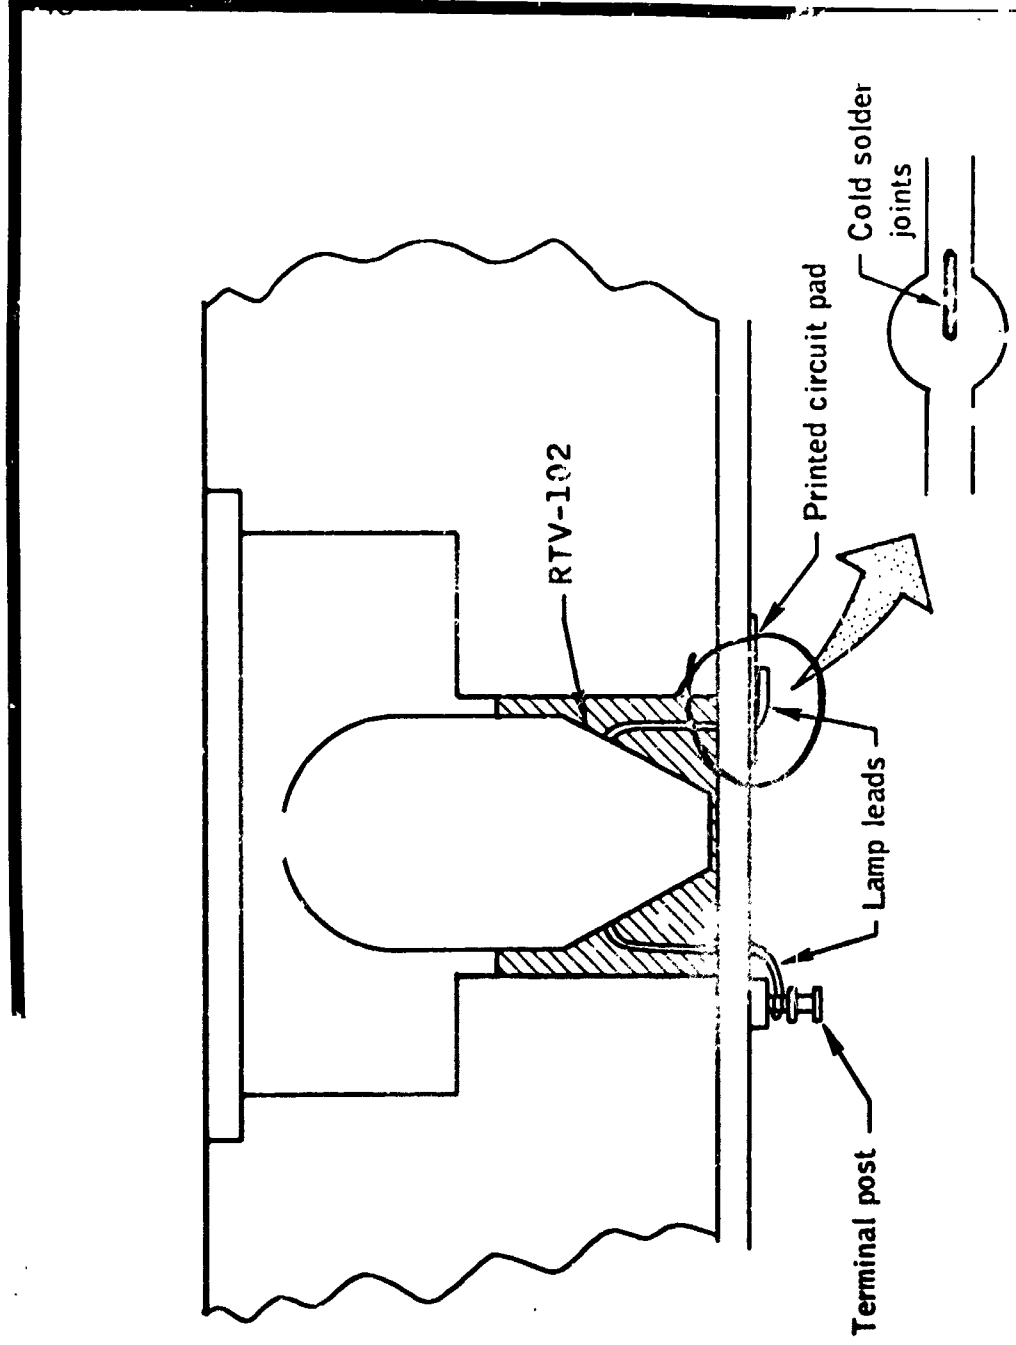
FIG. 2.2.15-1 LAMP ASSEMBLY

NO. 2.2.15	TITLE: EDS MODULE LIGHT BULBS FAILED INTERMITTENTLY
SYSTEM: CM	MISSION: APOLLO 10
SUBSYSTEM: EDS	EVENT TIME: PRE-LAUNCH
PROBLEM:	<p>DURING SPACECRAFT TESTING PRIOR TO LAUNCH, THE LAUNCH VEHICLE ENGINE WARNING INDICATORS OPERATED INTERMITTENTLY. THE INDICATOR FOR EACH OF THE FIVE ENGINES HAS TWO REDUNDANT MINIATURE LAMPS, AND ONE LAMP IN FOUR OF THE INDICATORS WAS INTERMITTENT.</p> <p>POSTFLIGHT, ONLY THREE OF THE FOUR LAMPS WERE INTERMITTENT. THE ANNUNCIATOR WAS REMOVED FROM THE SPACECRAFT AND DISASSEMBLED. ON SIX OF THE TEN LAMPS, INCLUDING THE FOUR INTERMITTENT ONES, COLD-SOLDER JOINTS WERE FOUND WHERE THE LAMP LEAD WAS ATTACHED TO THE PRINTED CIRCUIT BOARD. THE COLD-SOLDER JOINT WOULD HAVE CAUSED INTERMITTENT LAMP OPERATION.</p> <p>THERE ARE ALSO THREE OTHER STATUS LIGHTS IN EACH ANNUNCIATOR: LAUNCH VEHICLE OVERRATE, S-II SEPARATION, AND LAUNCH VEHICLE GUIDANCE FAIL. THE SIX BULBS IN THESE LIGHTS WERE NOT INTERMITTENT PRIOR TO LAUNCH NOR WERE ANY FAULTS FOUND IN THEM DURING POSTFLIGHT EXAMINATION.</p> <p>ACTION: THE UNITS FOR APOLLO 11 AND SUBSEQUENT VEHICLES HAVE BEEN SCREENED, WHEREAS THE APOLLO 10 UNIT HAD NOT BEEN.</p>
